G-III-B-124

The Art Butler House
Private
Accident

INVENTORY FORM FOR STATE HISTORIC SITES SURVEY

Art Butler House

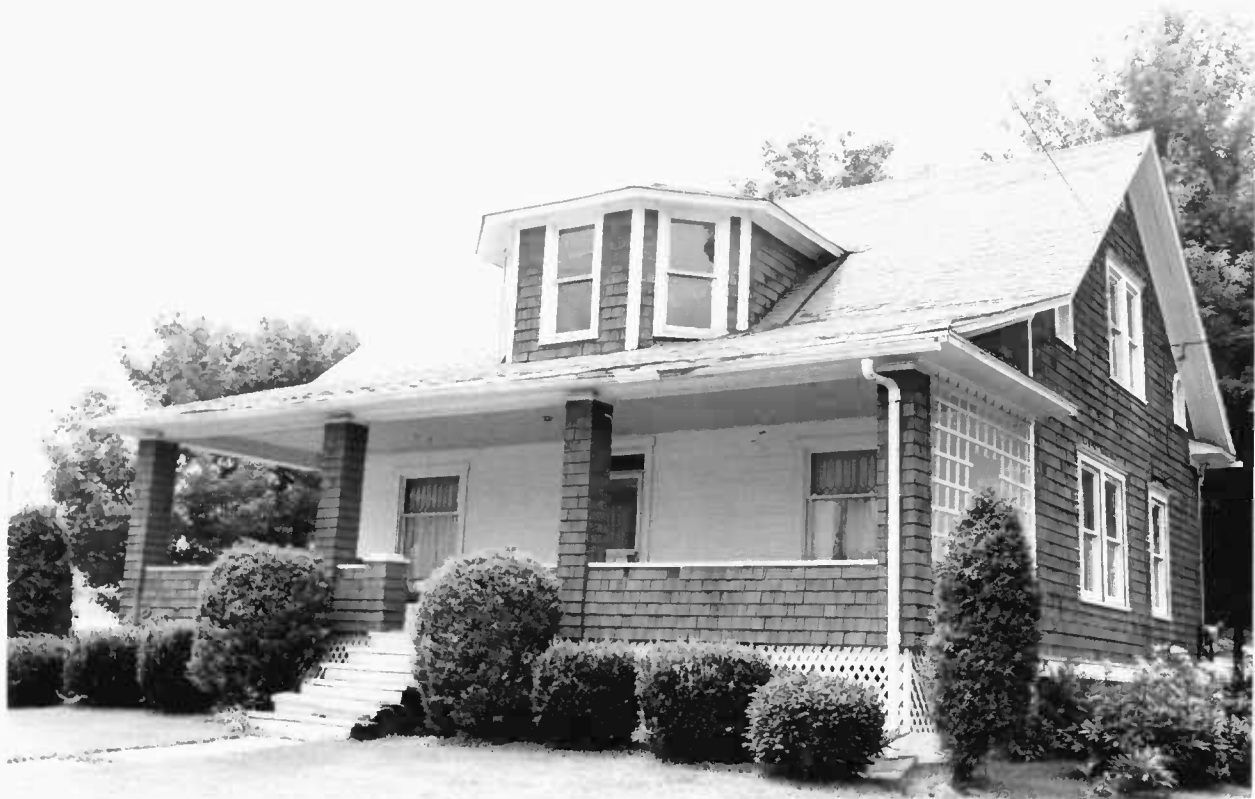
G-III-B-124

The house is a one and a half story, gable-roofed dwelling with a three-bay, center-door facade. The facade points southeast and is covered by a shed-roofed porch. The porch roof forms a catslide with the roof of the house. On the northwest elevation is a shed-roofed kitchen wing.

The house rests on a coursed stone foundation and the walls are covered with horizontal boards. The windows are 1/1 sash, with drip mouldings and plain board surrounds. On the facade the windows have narrow upper sashes filled with leaded eights and large single lower sashes. The facade door has a transom. On either side of the S.W. and N.E. gable ends are small round-arched windows.

Facade - SE;NE elev.

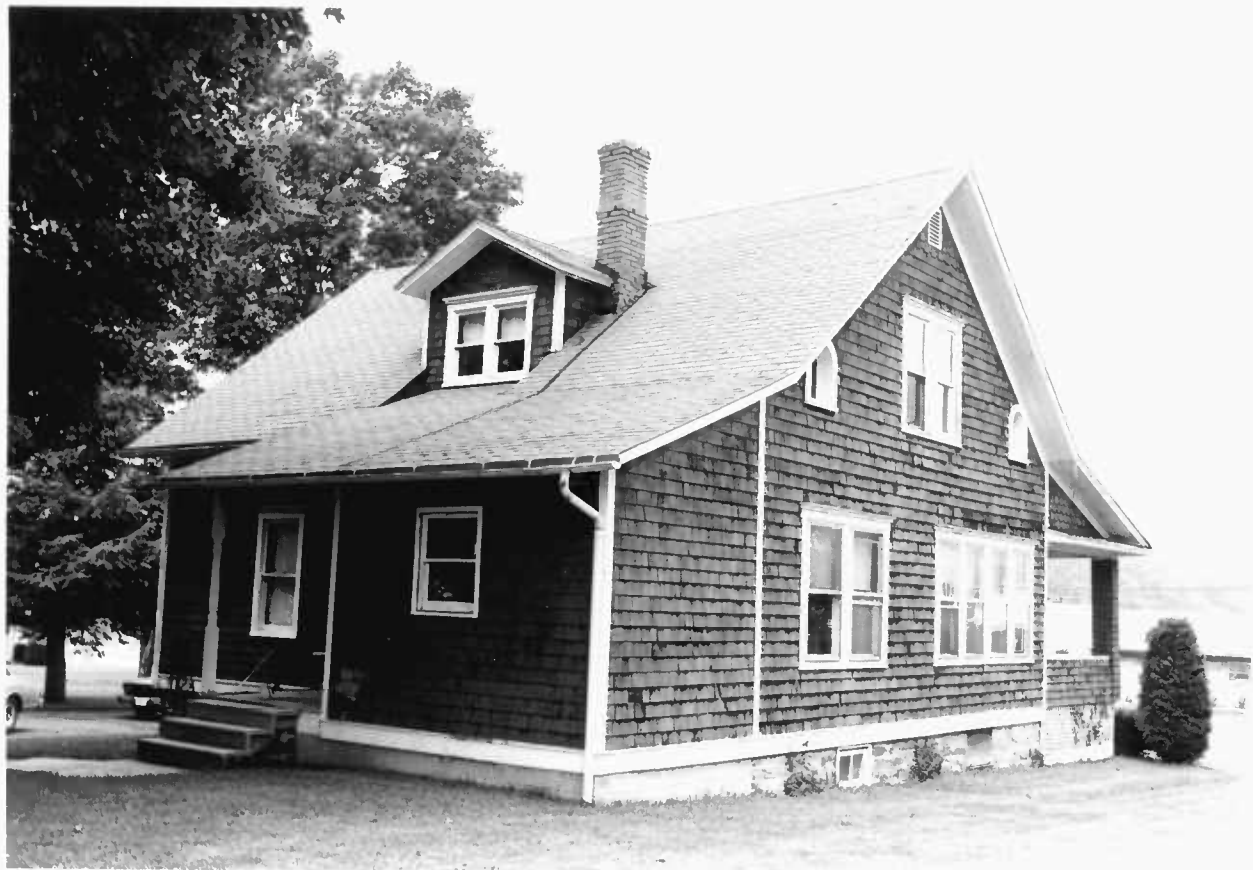
G-III-B-124

The roof is covered with asphalt shingles. At the center of the facade is a five-sided, hipped-roofed dormer. Three of its elevations have 1/1 sash windows. On the N.W. elevation is a gable-roofed dormer. The house has one interior stove chimney on the N.W. slope of the roof, attached to the dormer.

NW & SW elevs.
